# Property Flood Resilience

## 2020 update

Stories from homes and businesses who have made adaptations to help them recover more quickly after a flood

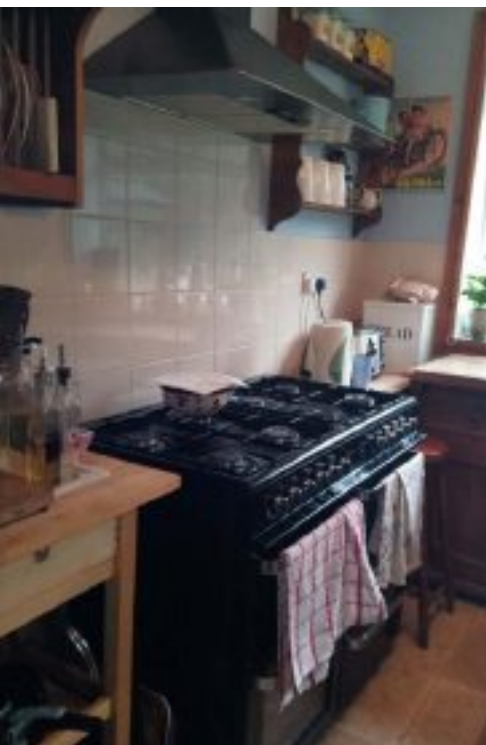
Solid wood kitchen units are freestanding so can easily be removed.

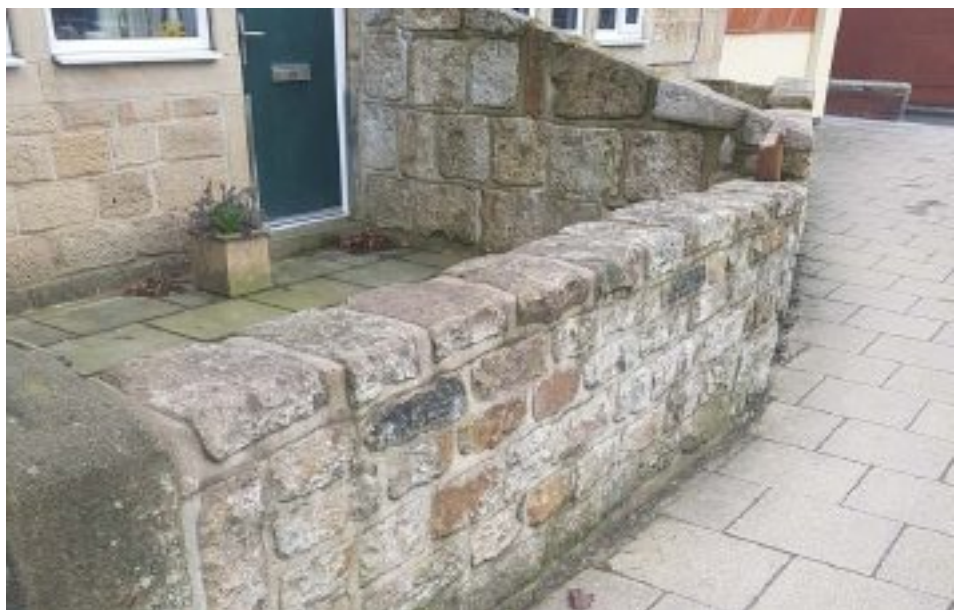
*New wall at front of house with a flood-proof gate*

Todmorden Resident told me that the flood water reached a good 20cm (8”) up the purpose-built wall and flood gate and it held fast. No insurance claim because there was no damage. Job done!

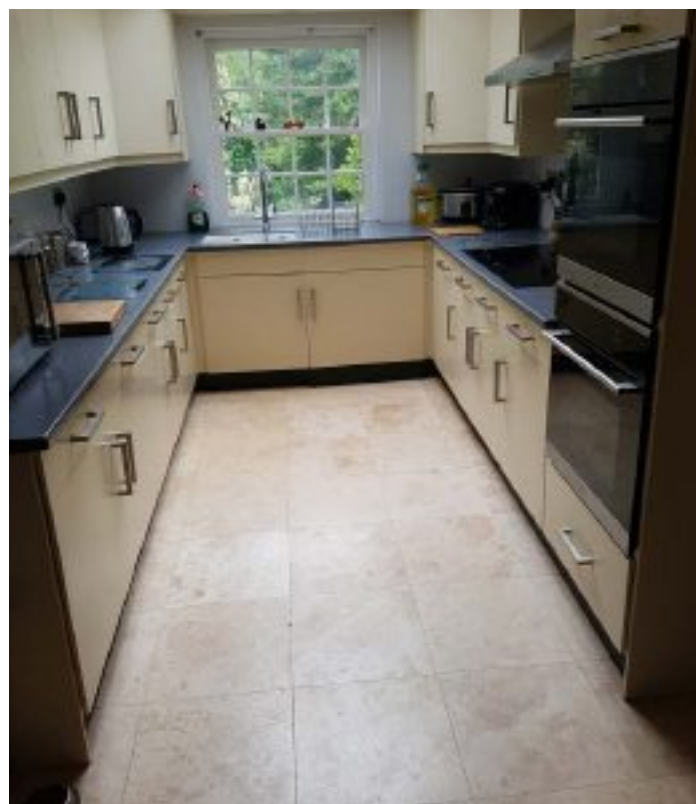
*A Corian plastic kitchen was fitted.*

He decided that because the kitchen was the most expensive item to replace, he would have a Corian plastic kitchen fitted. It appears that the company is no longer in existence, but a quick web search showed that Corian and laminated Aquoline kitchens are still available. He has stone tiled floors that survived the floods and now also has waterproof plaster on the walls.

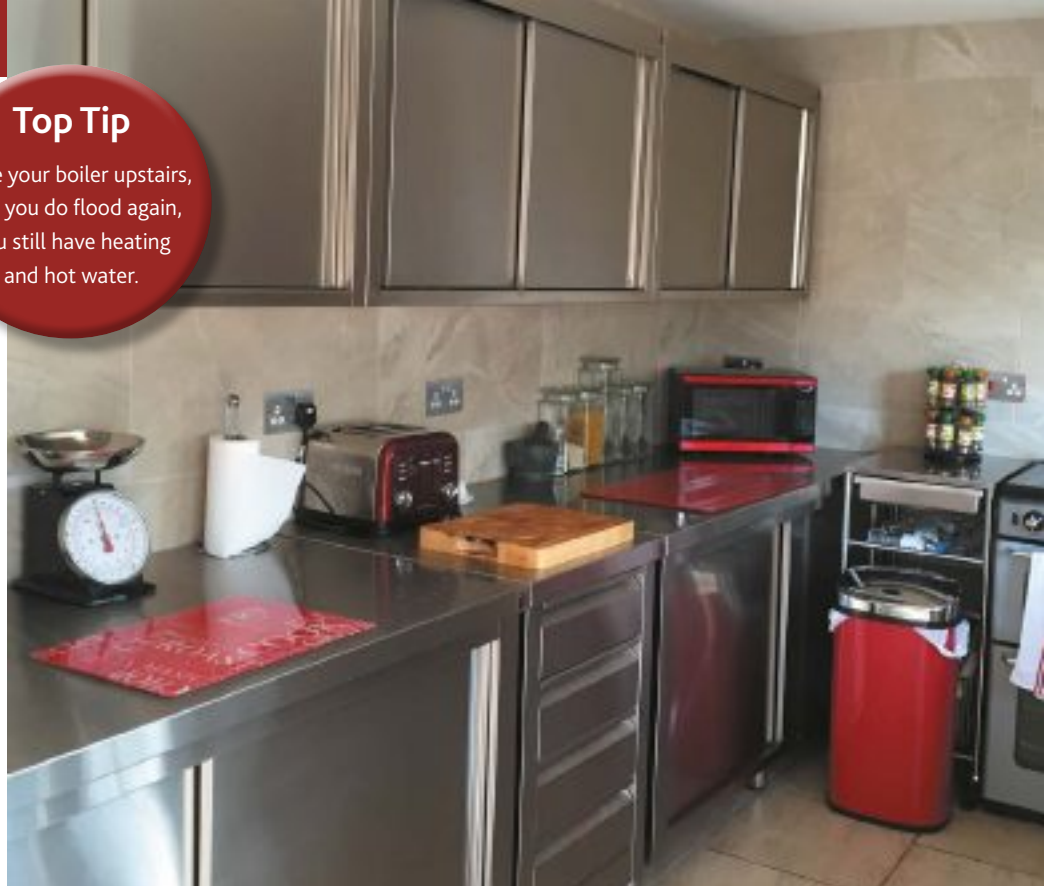
*Free-standing stainless steel kitchen with free-standing appliances.*

- Free-standing stainless steel kitchen with free-standing appliances, which can be moved to safety. The walls are tiled from floor to ceiling, using water-resistant cement and grout; internal door re-hung with hinges allowing it to be lifted off and moved upstairs.
- A flood-resistant door has been installed, which allows additional time for moving items before the water has to be let in.
- The ground floor is tiled throughout, using water resistant cement and grout – it can be hosed down and disinfected after a flood.
- The window sills are made of hardwood instead of the usual easily-damaged softwood.
- The fireplace surround is also made from hardwood, and has successfully survived a flood.

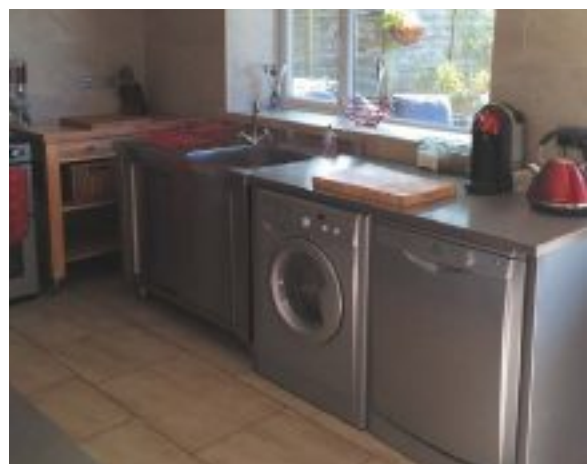
*The window sills are made of hardwood.*

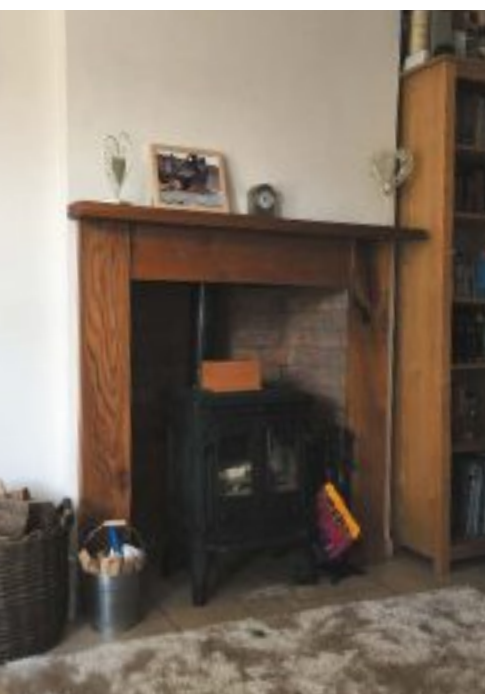
*The fireplace surround is also made from hardwood.*

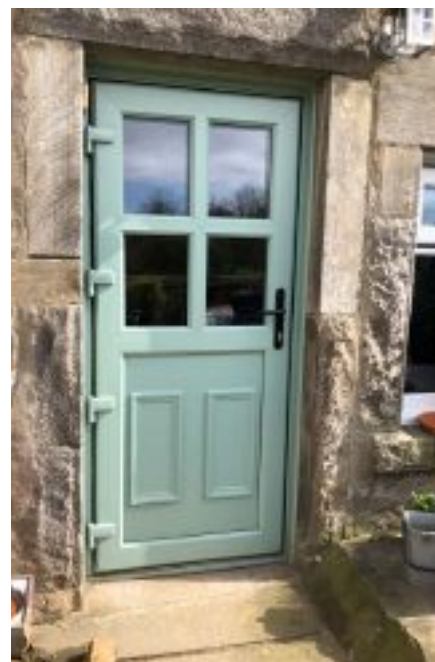
*Flood door fitted.*

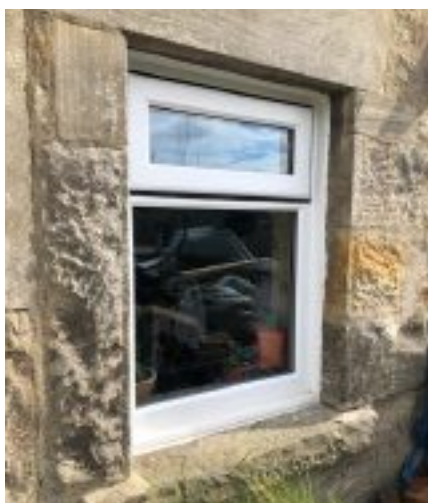
*Original window replaced with a flood proof window.*

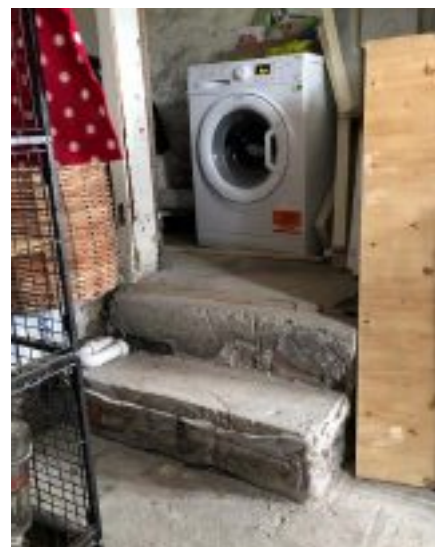
*White goods in the basement room are now raised up.*

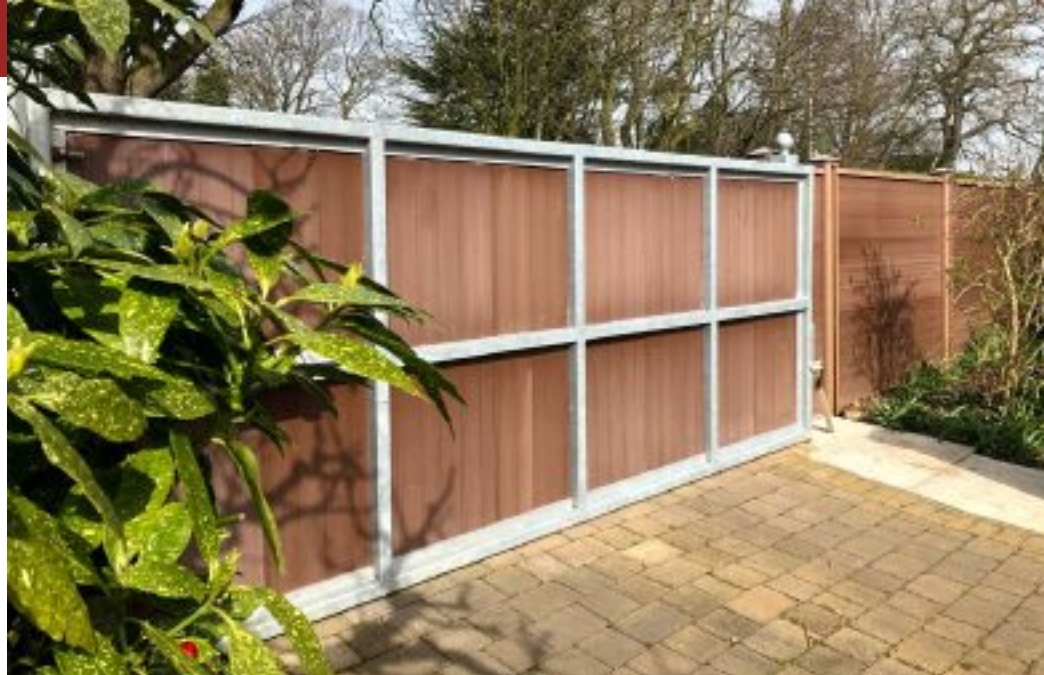
*The front entrance gate is the same material as the fence panels and is fitted tightly to prevent ingress of water.*

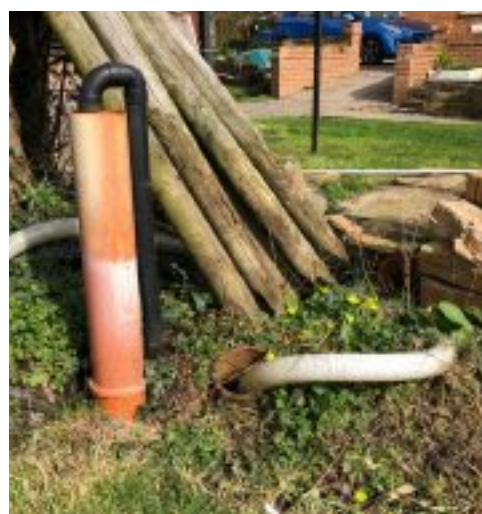
*Rainwater runs through a series of French drains into a large sump into which a strong pump is fitted which pumps the water outside the garden boundaries.*

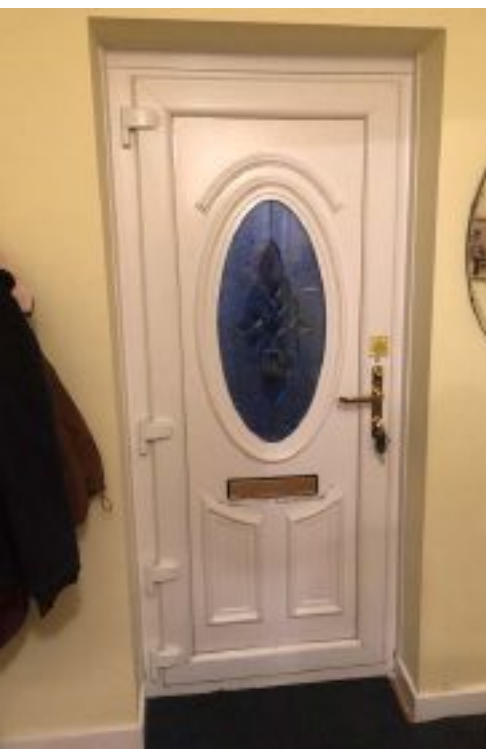
*Flood resilient front door has been installed.*

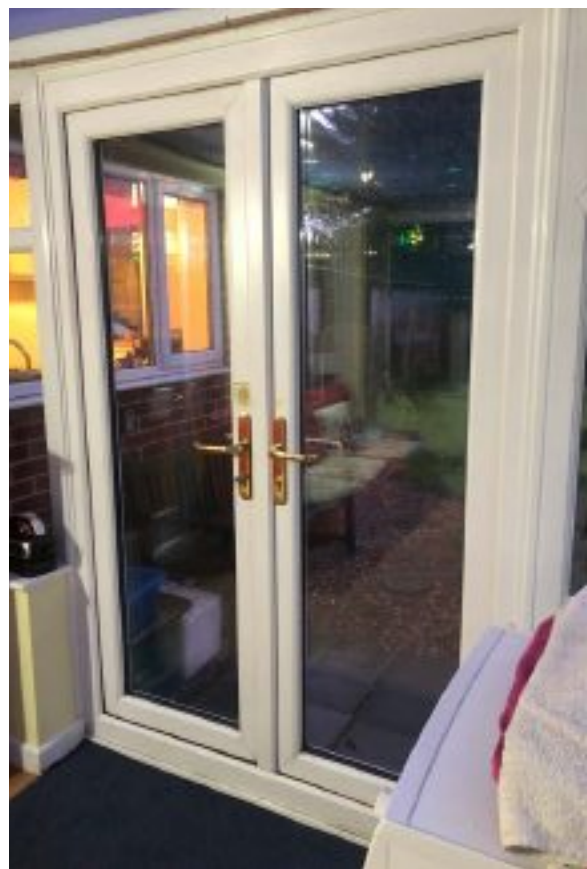
*Flood resilient patio doors have been installed.*

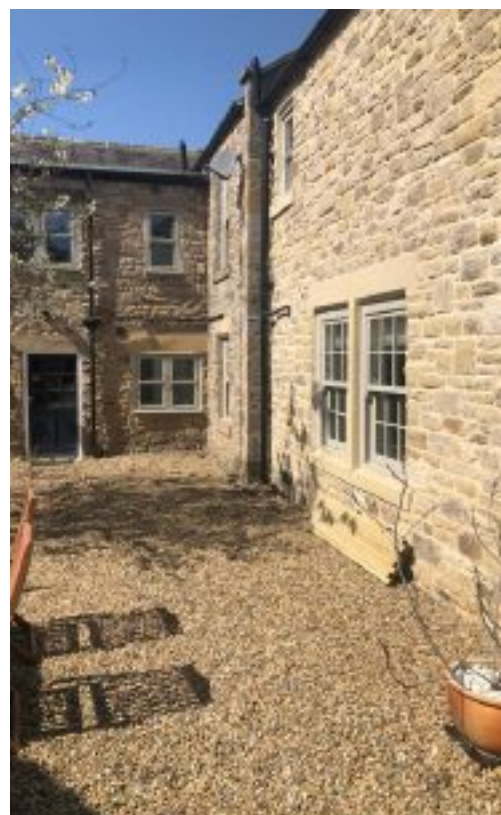
*Permeable patio areas surround most of the house.*

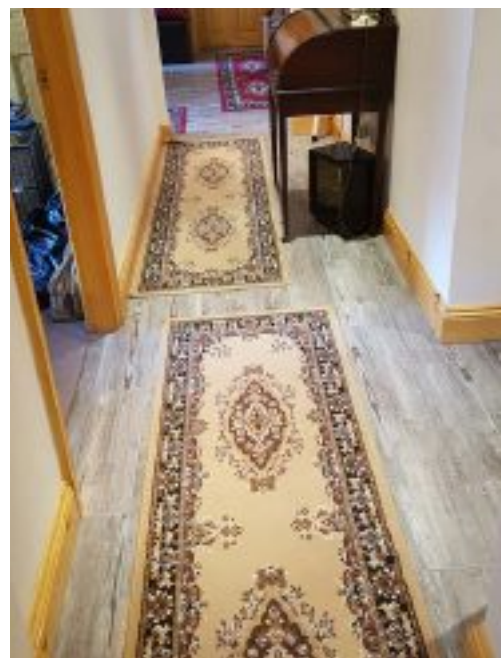
*Ceramic tiled hall with rugs.*

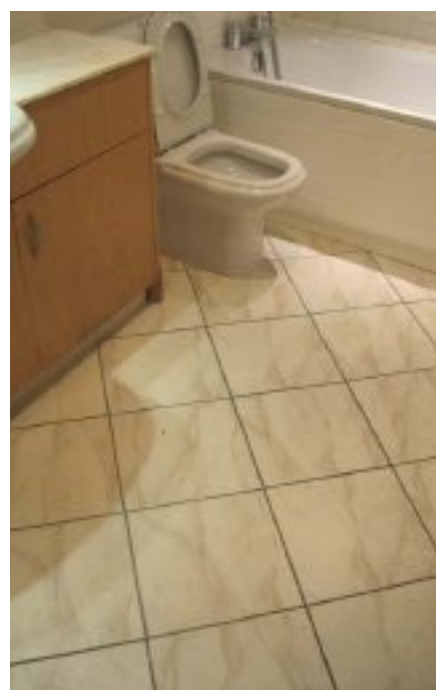
*Ceramic tiled bathroom floor.*

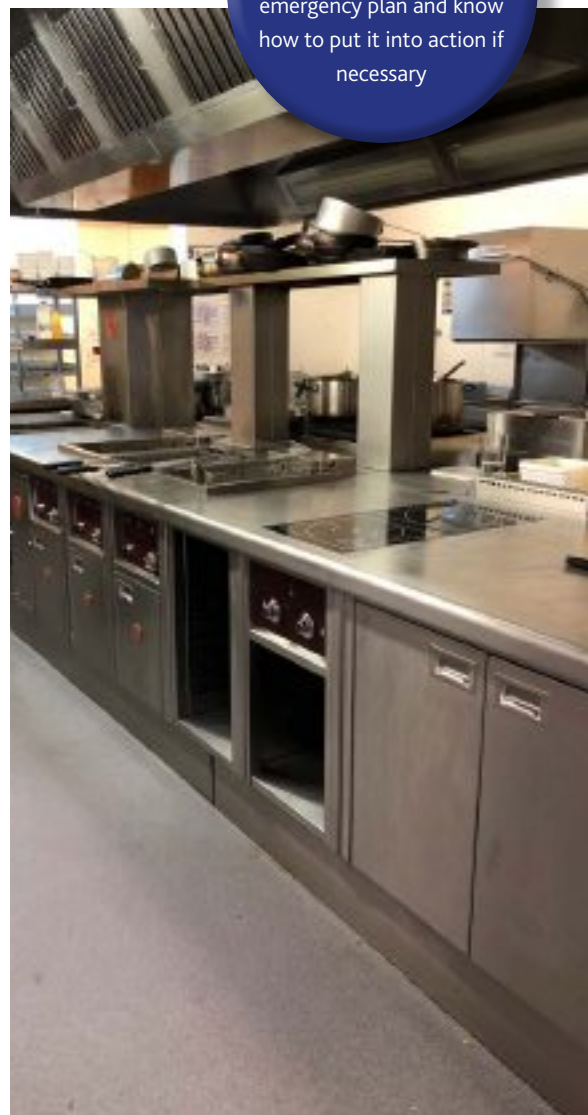
*The motor can be removed from the stainless-steel kitchen 'Chave block' (cooking area).*

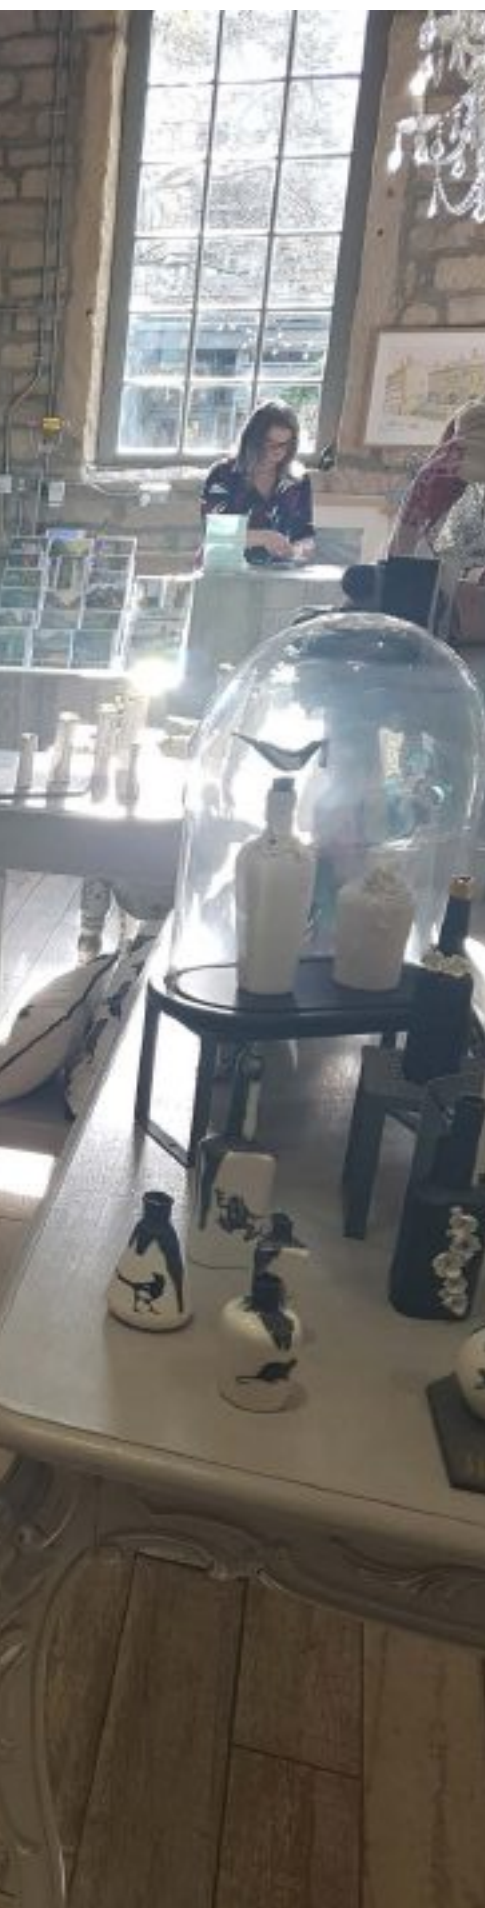
*Floor surface is finished with porcelain tiles patterned to mimic floorboards.*

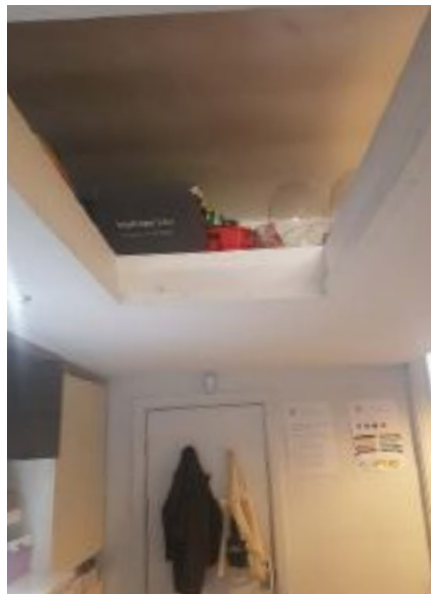
*A dedicated storage area has been created for flood-related equipment and easily damaged items.*

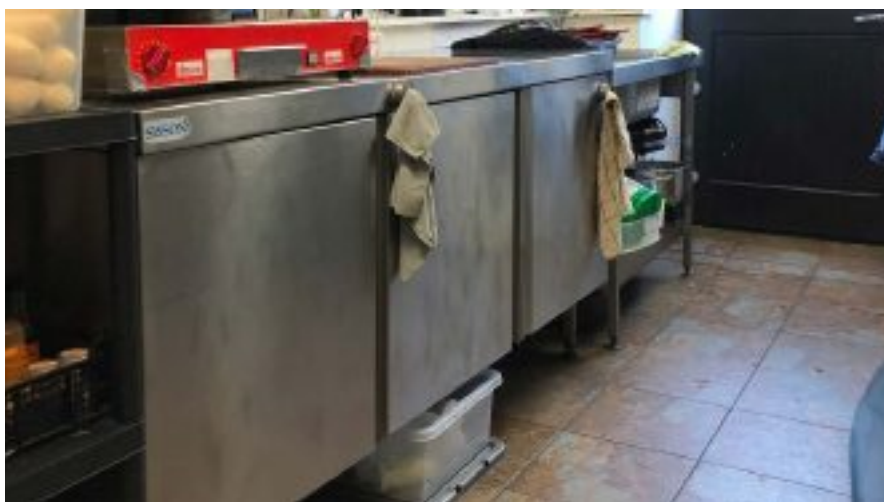
*Stainless steel kitchen*

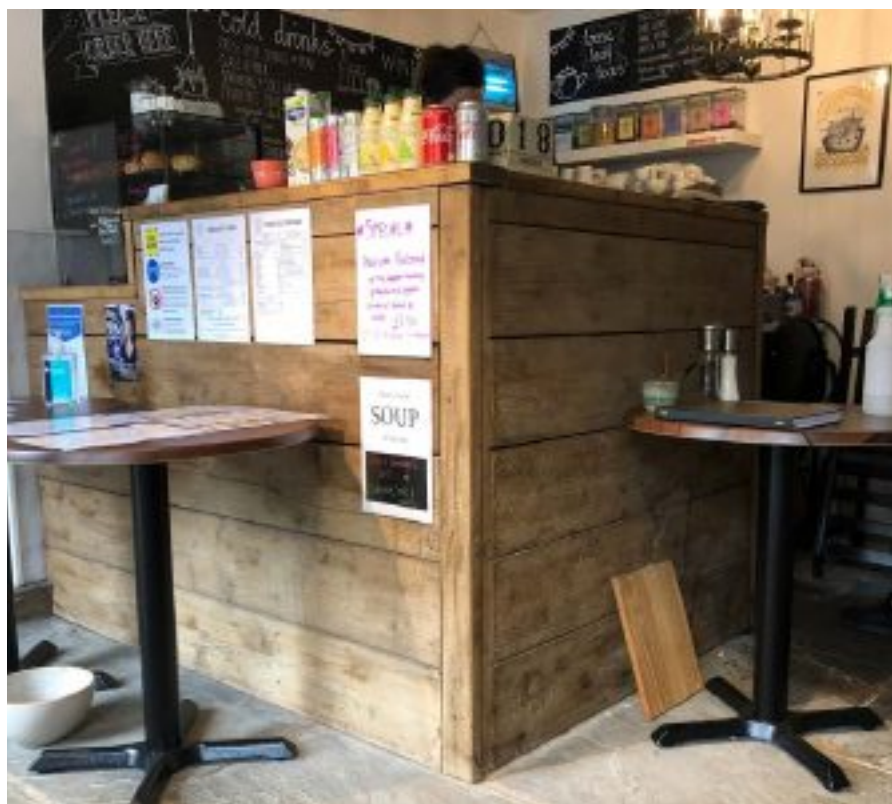
*Main counter made of varnished scaffolding planks.*

- Laid a stone floor using waterproof grout and adhesive.
- Installed thick wooden skirting boards and gave them several coats of varnish.
- Fitted a new main counter, which is made of varnished scaffolding planks.
- Some walls are stone and can be washed down after any future flood.

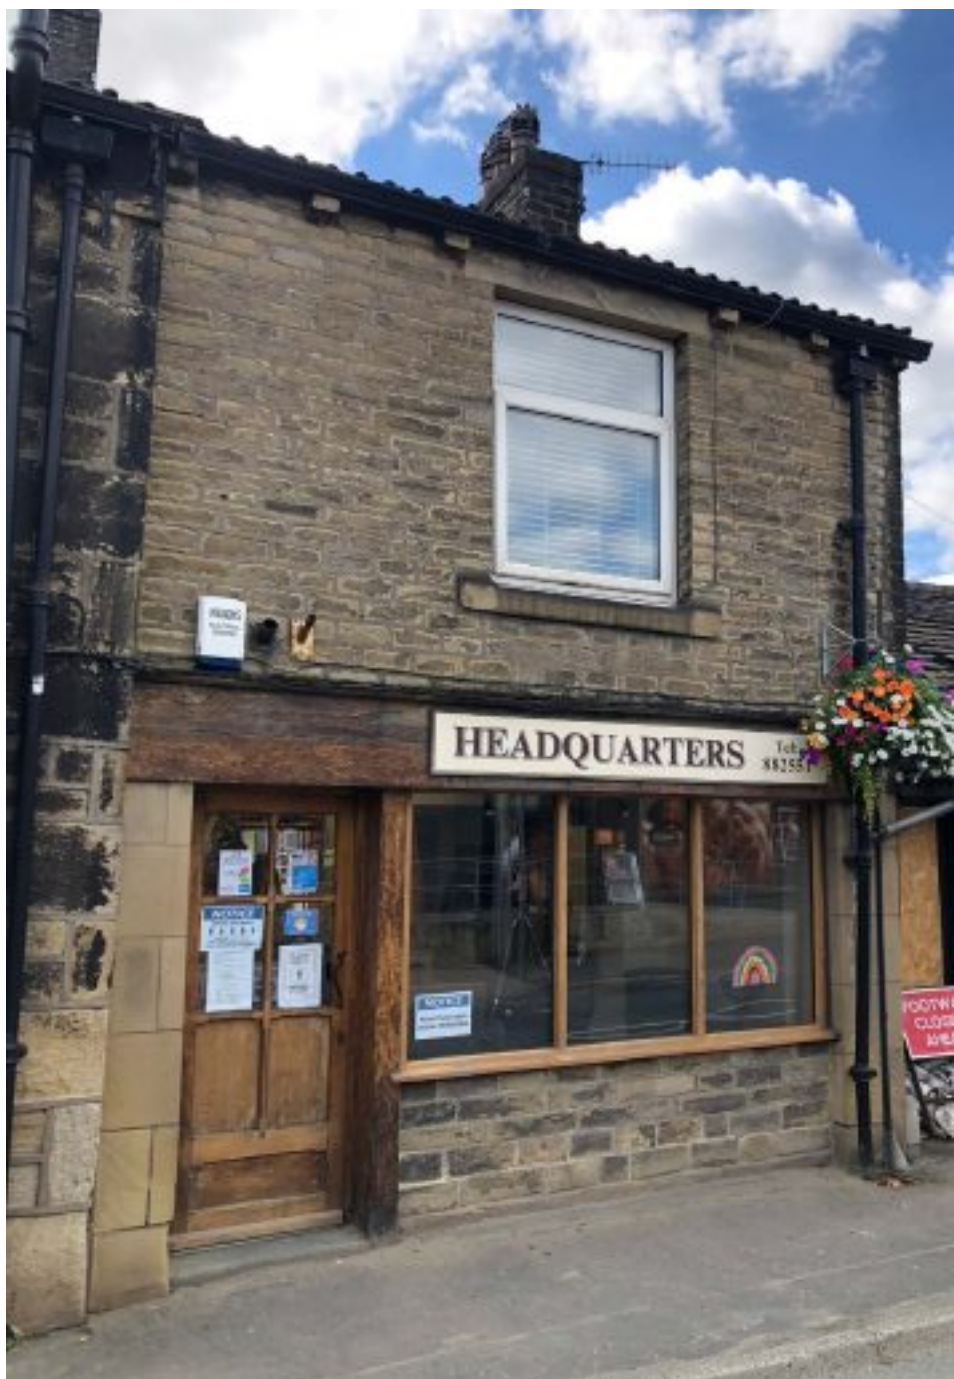
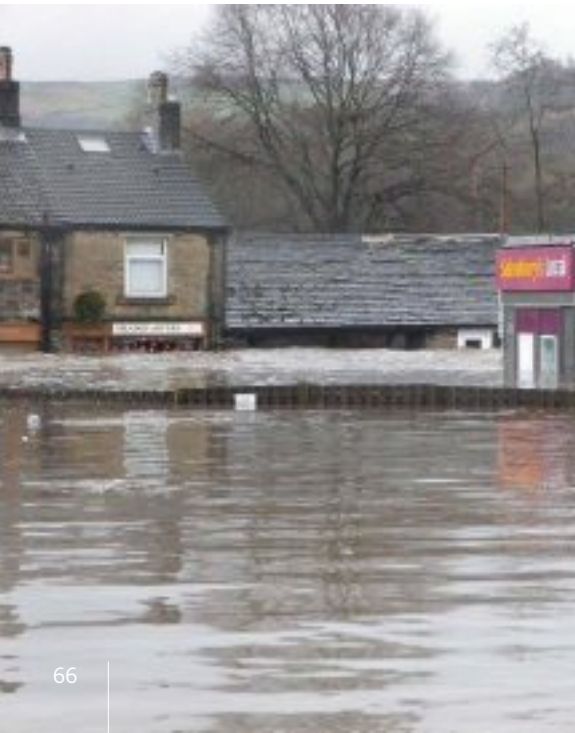
*The pressure of the flood water inside caused the windows to blow outwards when the flood receded.*

The pressure from this caused the windows to blow outwards. Sue says she was incredibly lucky, as a nearby hairdressers that had not flooded, allowed her to run her business from there. Had she not been able to do that, she would have had no income for the 9 months it took to repair her salon. The insurance bill was about £30,000 and sadly after this flood, Sue was unable to obtain any flood insurance.

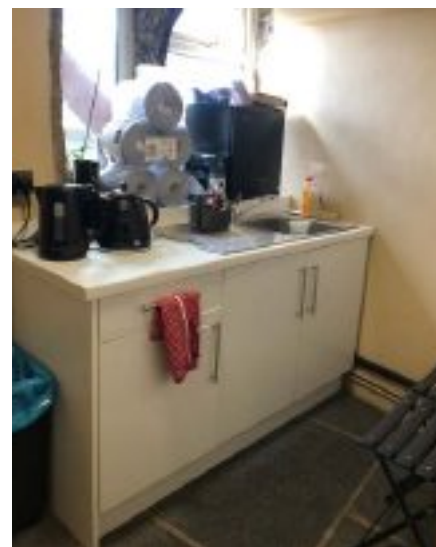
*A plastic kitchen was installed.*
