## **Empirical Insights from Post-Event Coastal Flood Damage Surveys after Hurricanes Helene and Milton in Florida**

**Ahmed U. Abdelhady\* and Raulina Wojtkiewicz**

Catastrophe and Risk Solutions, Verisk, Boston, MA, 02111, USA

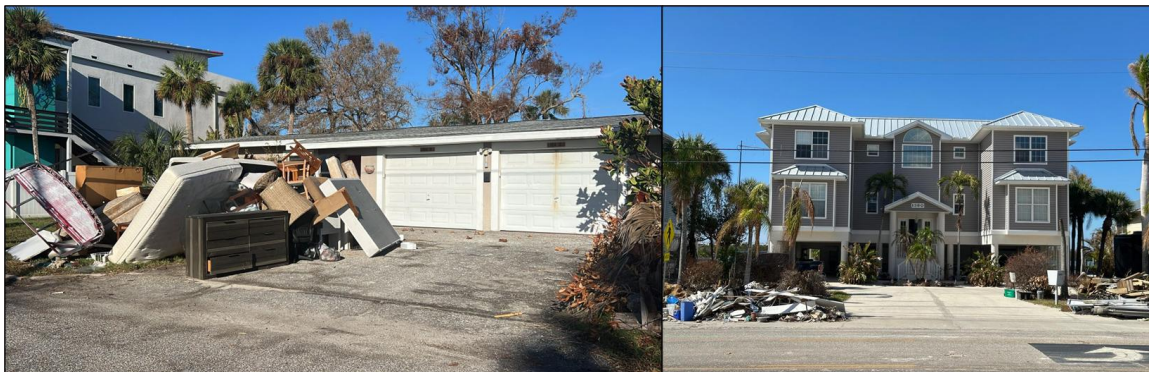
Single-family residential buildings constituted a significant portion, around 65%, of the surveyed structures. As shown in fig. 2-4, for non-elevated homes, floodwaters frequently entered living spaces, resulting in extensive damage to interior finishes, wall assemblies, flooring, and household contents. Exterior damage was typically limited to lower wall finishes, doors, and garage components, though prolonged exposure led to staining, material deterioration, and contamination.

Figure 3: Widespread damage to interiors and content was found in most of the surveyed residential neighbourhoods

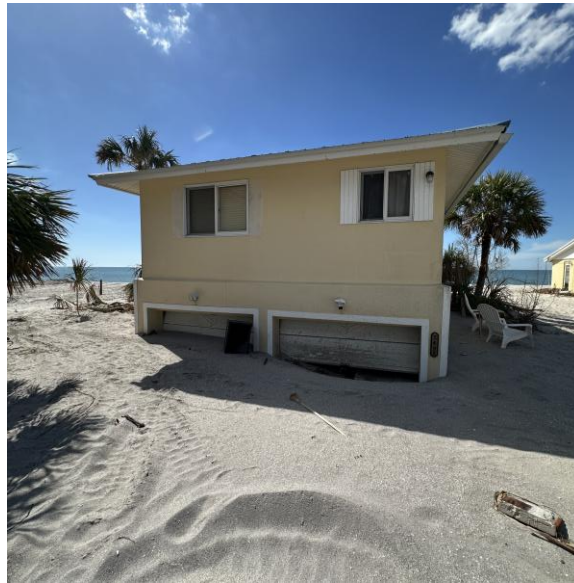
Figure 4: A coastal house that is covered in 3-4 ft of silt and mud in Manasota Key.

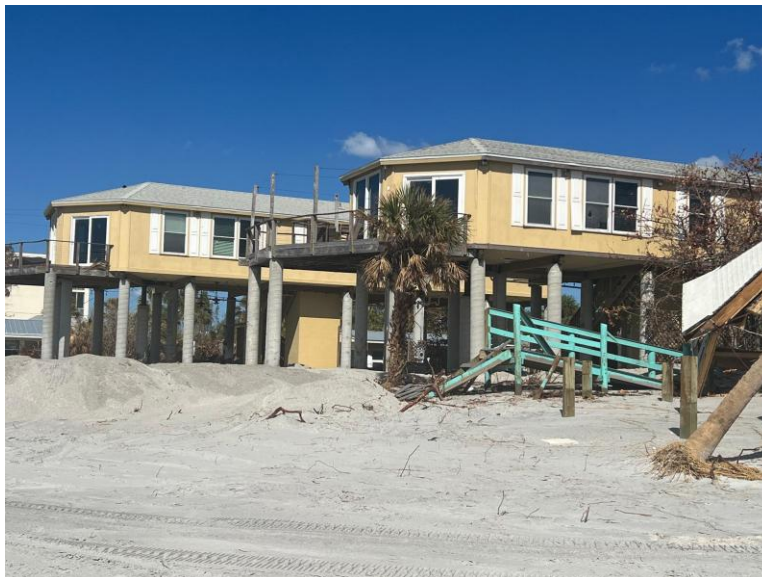
In contrast, fig. 5 and 6, elevated residential buildings often exhibited minimal damage to primary living spaces, even when evidence of surge inundation was present at ground level. For these structures, observed damage was largely confined to garages, storage areas, or unoccupied lower levels. These contrasting performance outcomes were frequently observed between neighbouring homes subjected to similar flood depths, underscoring the influence of building elevation and configuration on damage severity.

Figure 5: Elevated buildings, on the coast in Manasota Key, suffered minimal damage.

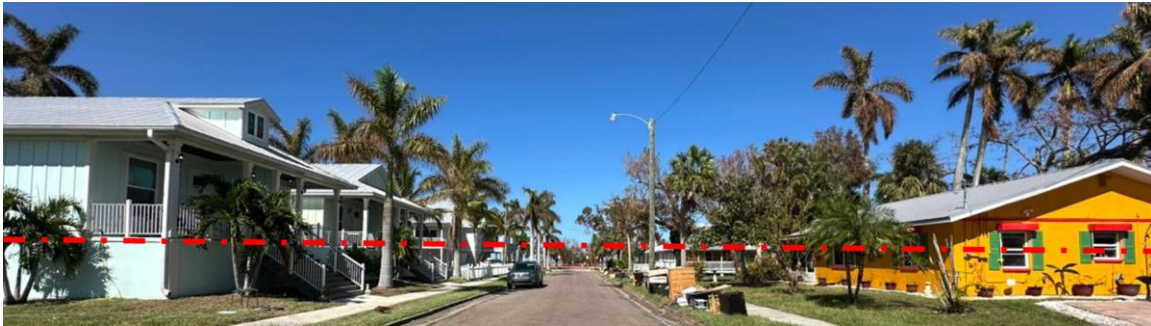
Figure 6: Two single-family houses across the street from each other, affected by around 4 feet of storm surge, in Punta Gorda.

Figure 6 shows a representative example observed during the surveys involved two single-family homes located directly across the street from one another, both exposed to approximately 3–4 ft of storm surge inundation. The non-elevated home experienced substantial interior damage, including impacts to wall finishes, flooring, and building services, along with minor exterior damage. In contrast, the adjacent elevated home showed almost no observable damage, with floodwaters restricted to the lower, non-habitable level. This side-by-side comparison highlights the effectiveness of elevation in mitigating flood damage under similar hazard intensity and exposure conditions.

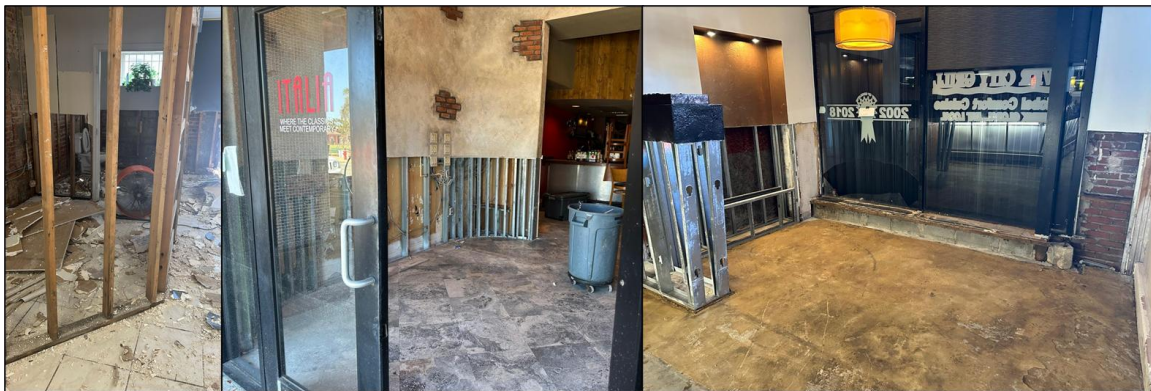
Low-rise commercial buildings in coastal areas experienced damage patterns similar to residential structures but often at larger scales. Ground-floor commercial spaces showed widespread interior damage, including failure of drywall systems, damage to electrical and mechanical equipment, and loss of inventory as shown in figure 7. In several cases, thick sediment deposits covered entire ground-floor areas, complicating cleanup efforts and extending business interruption periods.

Figure 7: Interior and content damage of commercial buildings in Punta Gorda.

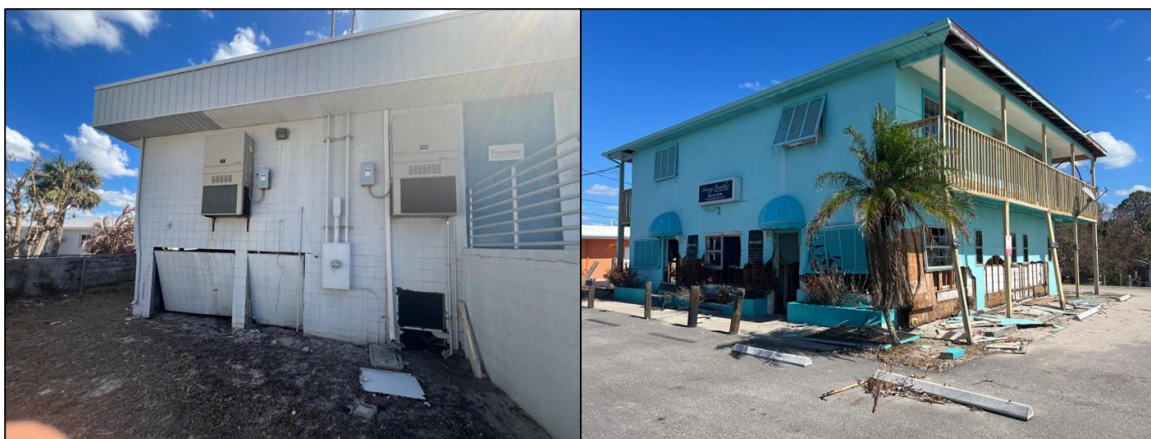
Commercial buildings located within the immediate coastal zone were particularly susceptible to flood damage due to slab-on-grade construction and limited elevation above surrounding grade. As shown in figure 8, exterior walls, exterior signage, storefront glazing, and service equipment were commonly damaged or displaced, although structural frame damage was generally limited.

Figure 8: Low-rise commercial buildings, near the coastline, suffered damage to exterior walls and windows due to storm surge in Manasota Key.

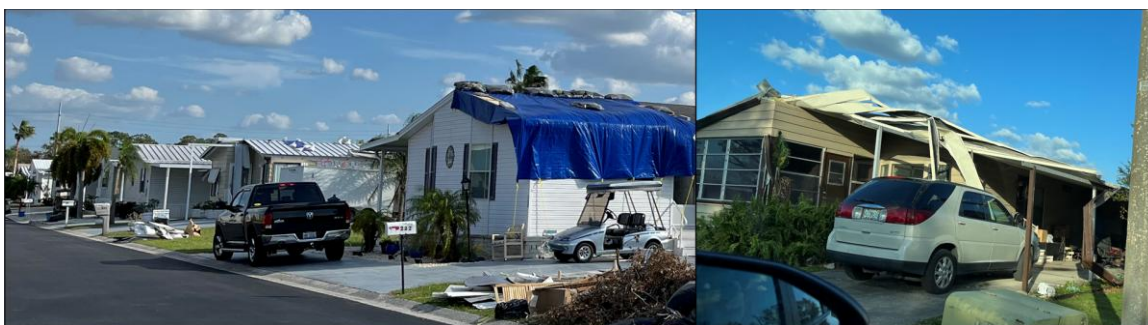
Although the focus of this study is flood damage, evidence of wind-related impacts was observed in several surveyed communities, figure 9. This included roof covering damage, loss of exterior attachments, and damage to carports and screened enclosures, particularly in mobile and manufactured housing. In some cases, wind damage may have increased flood vulnerability by creating additional pathways for water entry. Distinguishing between wind and flood damage was not always possible using exterior observations alone and represents a source of uncertainty in damage interpretation.

Figure 9: Widespread roof damages for mobile/manufactured homes in Hillsborough County.
